# COMPARISON OF MECHANICAL SUPPRESSION BY SHOT PEENING AND LOW PLASTICITY BURNISHING TO MITIGATE SCC AND CORROSION FATIGUE FAILURES IN 300M LANDING GEAR STEEL

N. Jayaraman and P. Prevéy

Lambda Research, 5521, Fair Lane, Cincinnati, OH 45227-3401

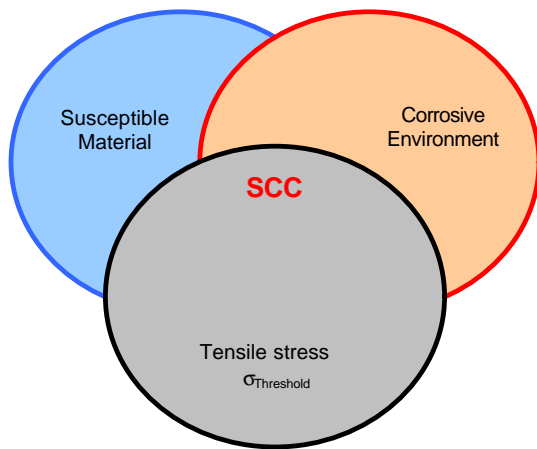
Figure 1 - SCC susceptibility diagram

SCC, corrosion fatigue, and FOD are generally recognized as significant degradation processes that affect aircraft landing gear components.<sup>1</sup> The phenomenon of SCC is generally understood to be the result of a combination of susceptible material, corrosive environment, and tensile stress above a threshold (Figure 1). Conventional SCC mitigation includes modifying the material (alloy chemistry) or the use of protective coatings to eliminate contact with the corrosive environment. A novel approach of "mechanical suppression" of SCC and corrosion fatigue by introducing deep surface residual compressive stresses by LPB<sup>2-5</sup> is presented in this paper. LPB can be performed on CNC machine tools at costs and speeds comparable to conventional machining operations such as surface milling.

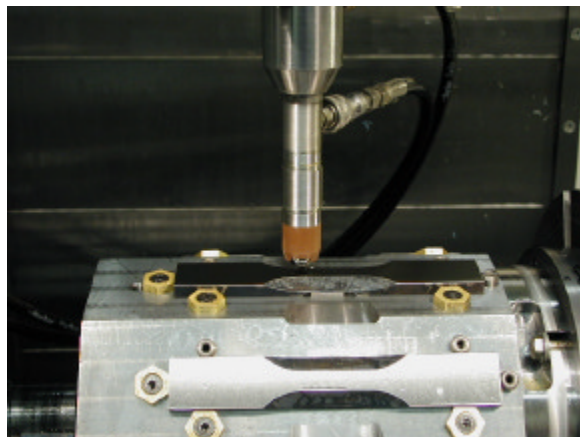
Figure 2 - A set of 8 thick section specimens being LPB processed in a 4-axis CNC milling machine.

300M steel was procured in the form of ~12.7 mm (0.5 in.) thick plates. Thick section bending fatigue specimens<sup>2-5</sup> (Figure 2) were machined and heat-treated. The tensile properties of the heat-treated

Surface Enhancement Technologies, LLC. (SET) developed the LPB process parameters for thick sections of 300M steel using proprietary methods. The CNC control code was modified to allow positioning of the LPB tool in a series of passes along the

gage section (Figure 2) while controlling the burnishing pressure to develop the desired magnitude of compressive stress with relatively low cold working. Shot peening was performed using CCW14 shot for 150% coverage at 8A and 10A intensities. Residual stresses were measured using a conventional x-ray diffraction ( $\text{Sin}^2\psi$ ) method on all surface treated specimens, before and after exposure to 400°F for 48 hours, which simulates the hydrogen bake-out treatment following cadmium or chromium plating.

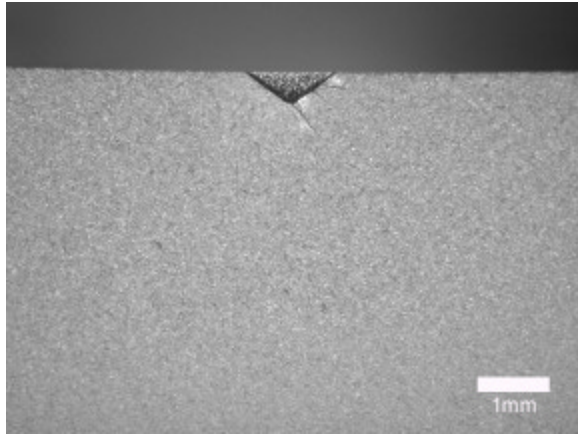
FIGURE 3 - Cross-section of 0.5 mm deep EDM notch to simulate FOD.

HCF tests were performed under constant amplitude loading on a Sonntag SF-1U fatigue machine, with ambient temperature (~72°F) in four-point bending mode, at a stress ratio,  $R = \sigma_{\min}/\sigma_{\max} = 0.1$ , and cyclic frequency of 30 Hz. FOD was simulated with a semi-elliptical surface EDM notch (Figure 3) introduced into the center of the gage section. Corrosion fatigue testing was performed in neutral 3.5% NaCl salt solution made with de-ionized water. Filter papers were soaked with the salt solution, wrapped around the gage section of the fatigue test specimen (Figure 4), and sealed with tape and a plastic film to avoid evaporation. The salt solution contacted the sample surface for only moments before the initiation of cyclic loading. The following is a list of test conditions used in this study:

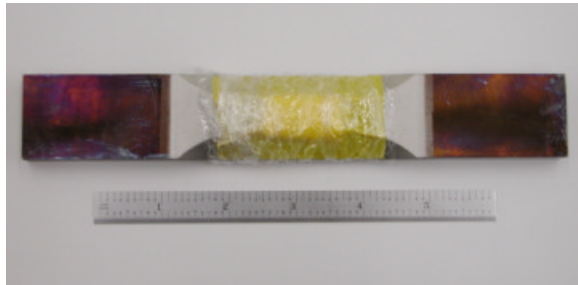
FIGURE 4 - A thick section specimen with salt solution soaked tissue wrapped around the gage section.

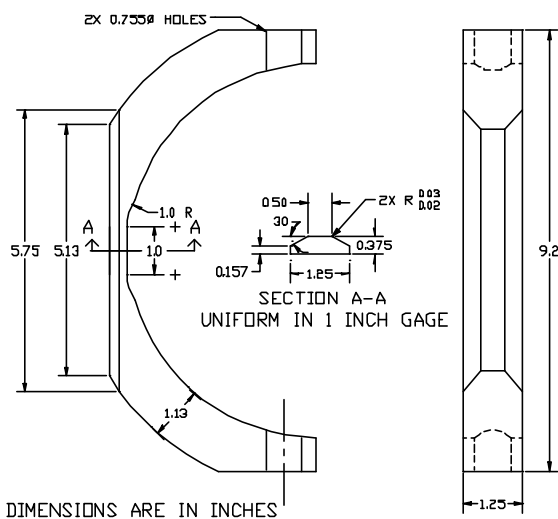
Figure 5 - C-ring specimen.

SCC tests were performed on C-ring specimens (Figure 5) machined from an actual 300M steel landing gear. The gage region of the C-ring specimen had a cross section similar to the bending fatigue specimens shown in Figure 2. The specimen is loaded with a bolt through the 19 mm (0.75 in.) hole, placing the outer surface in nominally uniform tension over the 25 mm (1 in.) long parallel gage section. Both untreated and LPB treated samples were SCC tested at 1033, 1137 and 1240 MPa (150, 165 and 180 ksi) static loads in alternate immersion (10 min. wet, 50 min. dry) in neutral 3.5% NaCl. The load was monitored as a function of time, with time to failure noted.

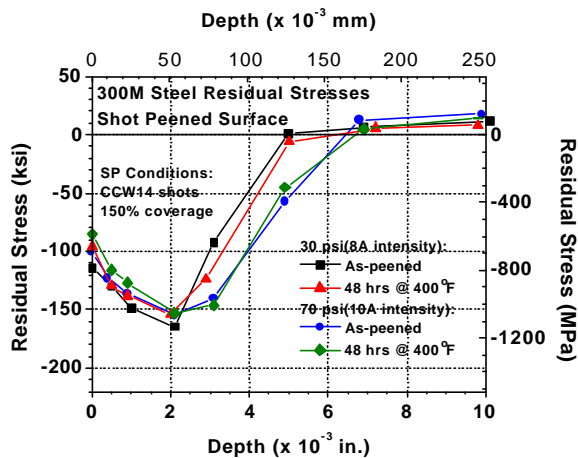
Figure 6 – SP subsurface residual stress distributions.

The residual stress distributions measured as functions of depth are presented graphically in Figures 6 and 7. Compressive stresses are shown as negative values and tensile stresses as positive. Compared to SP, LPB produced compressive residual stresses of greater magnitude, nominally – 1033 MPa (-150 ksi) for SP vs. -1240 MPa (-180 ksi) for LPB, and an order of magnitude greater depth. Thermal exposure to 400°F for 48 hours, simulating baking after electroplating, did not result in significant relaxation of either SP or LPB compression.

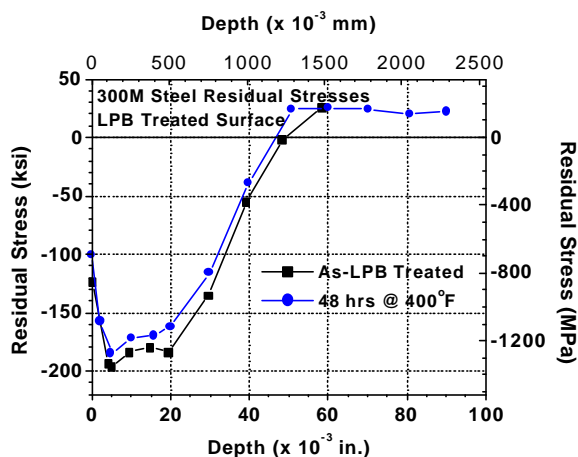
Figure 7 – LPB subsurface residual stress distributions.

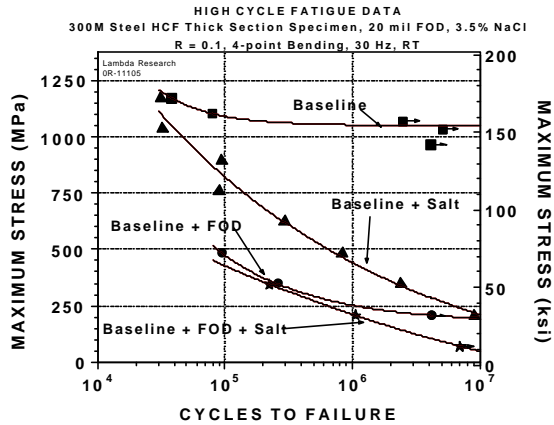
Figure 8 - Baseline fatigue results.

The HCF and corrosion fatigue performance of 300M steel is shown in Figures 8-11 as maximum stress S-N curves. Figure 8 shows the baseline material performance with and without the EDM notch and salt exposure. The unnotched baseline fatigue strength (endurance limit at  $10^7$  cycles) is nominally 1035 MPa (150 ksi). In the presence of a neutral salt solution, the baseline corrosion fatigue strength drops dramatically to about 205 MPa (30 ksi) with

loss of endurance limit behavior. Introduction of an EDM notch drastically decreases the fatigue strength to nominally 140 MPa (30 ksi) for air and to less than 70 MPa (10 ksi) in the salt environment. Power law lines were fitted to the data in Figure 8, representing the average behavior of the

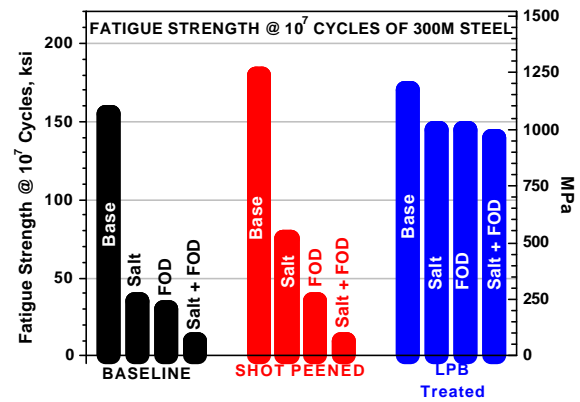
Figure 11 - Summary of fatigue results.

performance of the unnotched specimens. The corrosion fatigue strength in neutral salt is reduced to nominally 515 MPa (75 ksi), again with loss of endurance limit behavior. FOD 0.5 mm deep penetrates the SP layer and reduces the strength to that of the notched baseline condition in both air and neutral salt. Figure 10 shows the HCF and corrosion fatigue behavior of LPB treated specimens. The unnotched specimen shows superior HCF performance with a fatigue strength of 1200 MPa (175 ksi). Here, notched HCF and both notched and unnotched corrosion fatigue test results may all be grouped into one set of data at slightly lower fatigue strength of 1000 MPa (145 ksi), with the endurance limit behavior restored. Three conclusions may be reached from the fatigue data. First, the LPB process has effectively mitigated corrosion fatigue of 300M steel in salt water. Second, the HCF and corrosion fatigue performance of LPB treated 300M with either 0.5 mm FOD or salt-water exposure is statistically similar to the unnotched baseline material. Third, when tested in the neutral salt solution environment, the endurance limit behavior that was absent in both baseline and SP treatment is restored with the LPB treatment. These same results are summarized in the chart shown in Figure 11.

Fractographic analyses of the notched and other HCF test conditions yielded results that are expected and consistent with the fatigue test results shown in Figures 8-11. In baseline and SP conditions, the corrosion fatigue failure mechanism involved single or multiple crack initiation from shallow corrosion pits, whereas subsurface crack initiation (not from corrosion pits) was evident for the LPB condition. In all cases, some pitting of the gage surface was evident, and the cross-sectional views indicated a gradual increase in the depth of corrosion pitting damage with increased time of testing.

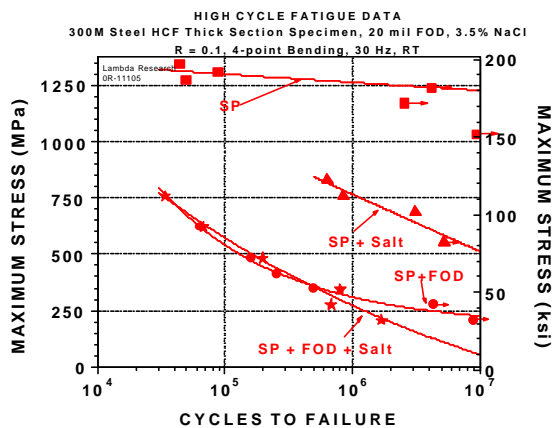
Figure 9 - Fatigue results for SP.

material in its baseline condition. The HCF and corrosion fatigue performance of both unnotched and notched SP treated specimens is shown in Figure 9. Benefits of surface compression from the SP treatment are clearly seen as improved HCF

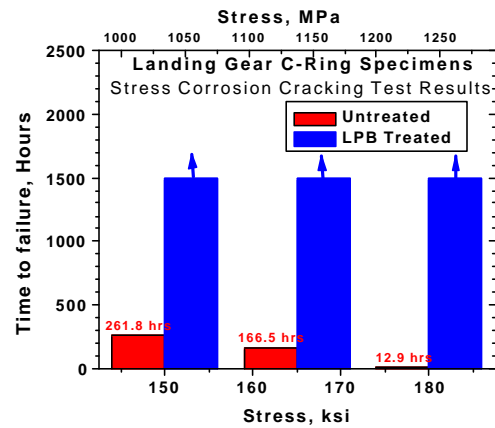
Figure 12 - SCC test results.

In Figure 12 the SCC test results show the untreated baseline material had SCC time to failure of 261.8 hrs at 1034 MPa (150 ksi), 166.5 hrs at 1138 MPa (165 ksi) and 12.9 hrs at 1241 MPa (180 ksi), respectively. The LPB treated specimens did not fail even after 1500 hrs of exposure at all the three stress levels. When the specimens were loaded to higher stress levels, instead of cracking, the specimens were severely bent at higher loads. These results indicate the deep surface compressive stresses from LPB fully mitigated SCC as a failure mechanism.

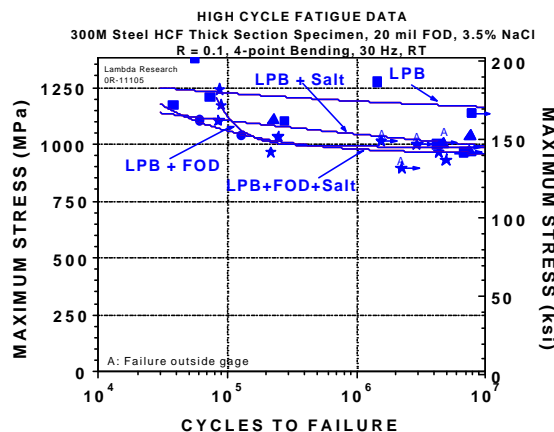
Figure 10 - Fatigue results for LPB
